Soviet IS-3 ‘Stalin’ Heavy Tank: Importance of Getting Assessment Right

by retired MAJ James M. Warford

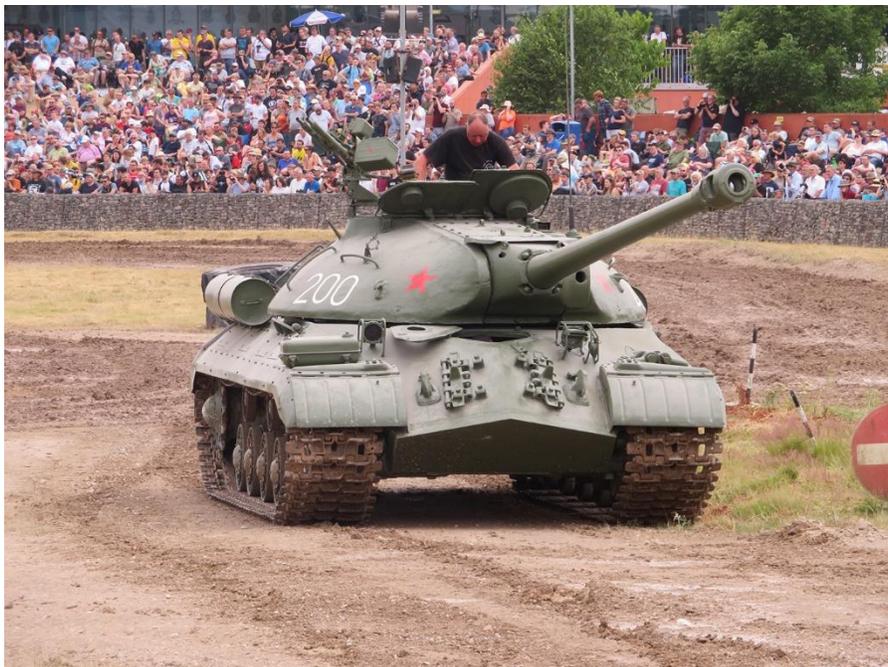
Figure 1. An IS-3M “Joseph Stalin” tank in the “Arena” at TankFest 2018. (Photo by the author)

The design of the IS-3, even by today’s standards, was impressive. The tank was built from the ground up to provide the best possible ballistic protection from all directions of attack. The new hemispherical turret and “pike-nose” glacis were both heavily armored and so well-shaped from a ballistic-protection point of view that they basically eliminated any potential weak points to attack. The IS-3 was fitted with the very powerful D-25T 122mm main gun, well-known by the end of World War II, that was a proven killer of German heavy armor during the war.

- Weight: 46 tons.
- Crew: four.
- Engine: 520 HP V-12 diesel.
- Speed: 25 mph.
- Armament: 122mm D-25T (12.7mm AA MG/7.62mm coax machinegun).
- Armor: Glacis: 4.7 inches (119mm) angled at 55 degrees = 8.2 inches (208mm); main gun mantlet: 7.9 inches (201mm) curved; turret sides: 7.9 inches (201mm) curved.
- Production: 1945-1946 (2,310 produced).

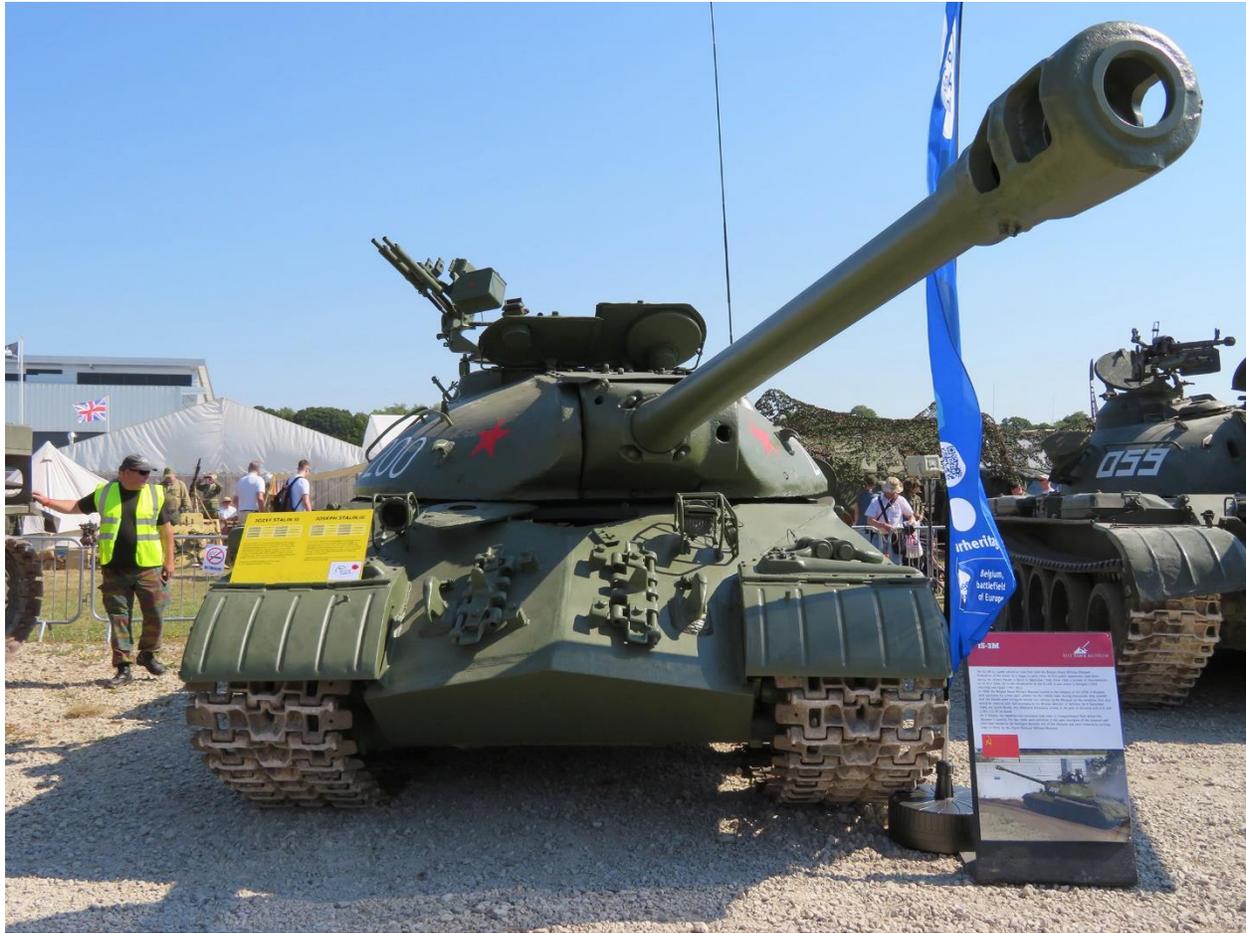
Figure 2. An IS-3M tank on static display at TankFest 2018. (Photo by the author)

The Soviets were very aware of these problems and launched a series of upgrade efforts for the IS-3 between 1948 and 1952. Perhaps the most significant upgrade took place in 1957, resulting in the improved and iconic Cold War version of the tank designated as the IS-3M. The tank’s reputation, however, seemed damaged beyond repair. Prior to the fielding of the IS-3M, the IS-3’s reputation actually went from bad to worse in 1956 when its performance was assessed after its first confirmed use in combat during the Soviet invasion of Hungary.
